Death in the line of duty...

A Summary of a NIOSH fire fighter fatality investigation

December 16, 2002

Civilian Jumps From Fourth-Story Window of Burning Apartment Building and Strikes Career Fire Fighter - Michigan

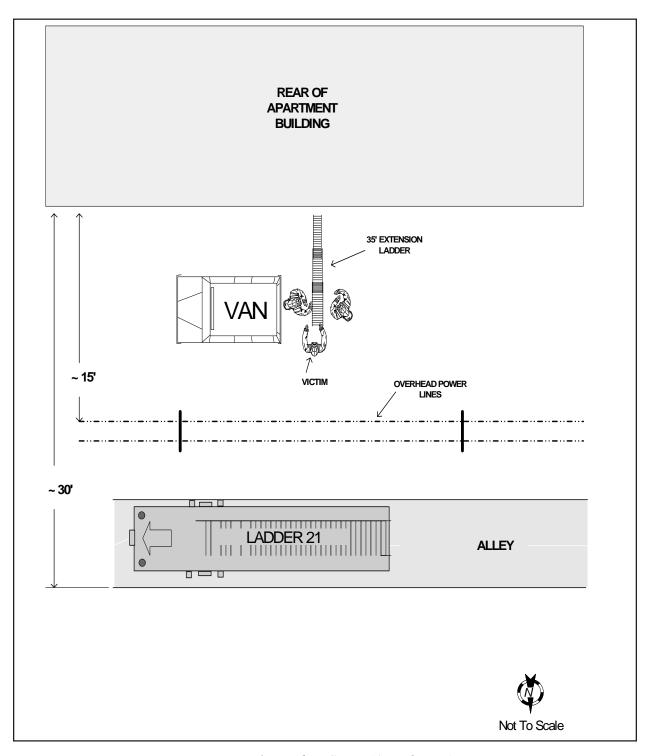
Diagram 1. Incident Scene (Aerial View)

Following the department SOPs, Ladder 21 proceeded down an alley and took a position for truck operations at the rear of the structure. Ladder 21 encountered additional civilians preparing to jump from the third and fourth floors. Two civilians were hanging out of a window on the fourth floor with fire at their backs. The hydraulic aerial ladder was unable to be put into service because of overhead electrical lines running parallel to the rear of the structure (Diagram #1). The two civilians were screaming for rescue with fire emitting from the top of the window behind them.

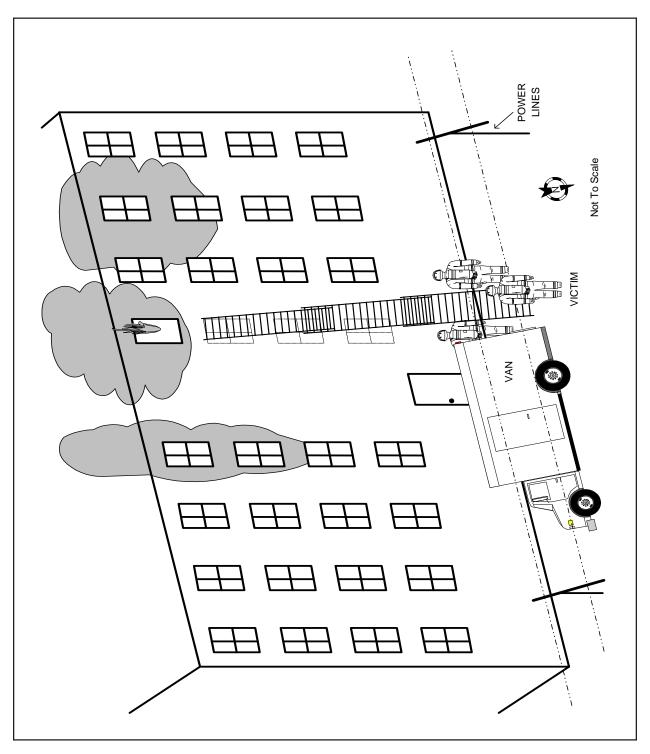
Diagram 2. Rear of Structure (Profile View)

The fire fighters were attempting to position the aluminum ladder at the base of a fourth-floor window to rescue an adult male and female who were trapped on the floor with fire at their backs. The three fire fighters struggled with the fully extended 35-foot ladder which was approximately 3 feet from the bottom of the window sill. As they were leaning the ladder to the building, the woman jumped from the window. She struck the top of the ladder and landed at the feet of the fire fighters. The male jumped immediately after, striking a van and the victim simultaneously (Diagram #2). The victim, who was bracing the base of the ladder, was knocked to the ground by the force of the jumper. He eventually made it to his feet and continued to rescue additional civilians with the 35-foot extension ladder. When additional fire fighters arrived on the scene, they were able to place the 50-foot extension ladder into service to rescue other civilians from the fourth floor. The victim put on his air pack and continued interior rescue operations and clean-up until returning at approximately 0415 hours to quarters, where he spent the remainder of his shift.
